1. For important limitations, please see *Hydraulic Modelling and Mapping in BC's Lower Mainland – Final Report* prepared for Fraser Basin Council by Northwest Hydraulic Consultants Ltd. (2019).

4. The map illustrates inundation extents and depths from selected single and multiple dike breaches. Dikes may breach in any number of locations in addition to those shown. Assumed breach characteristics and breach parameters may vary.

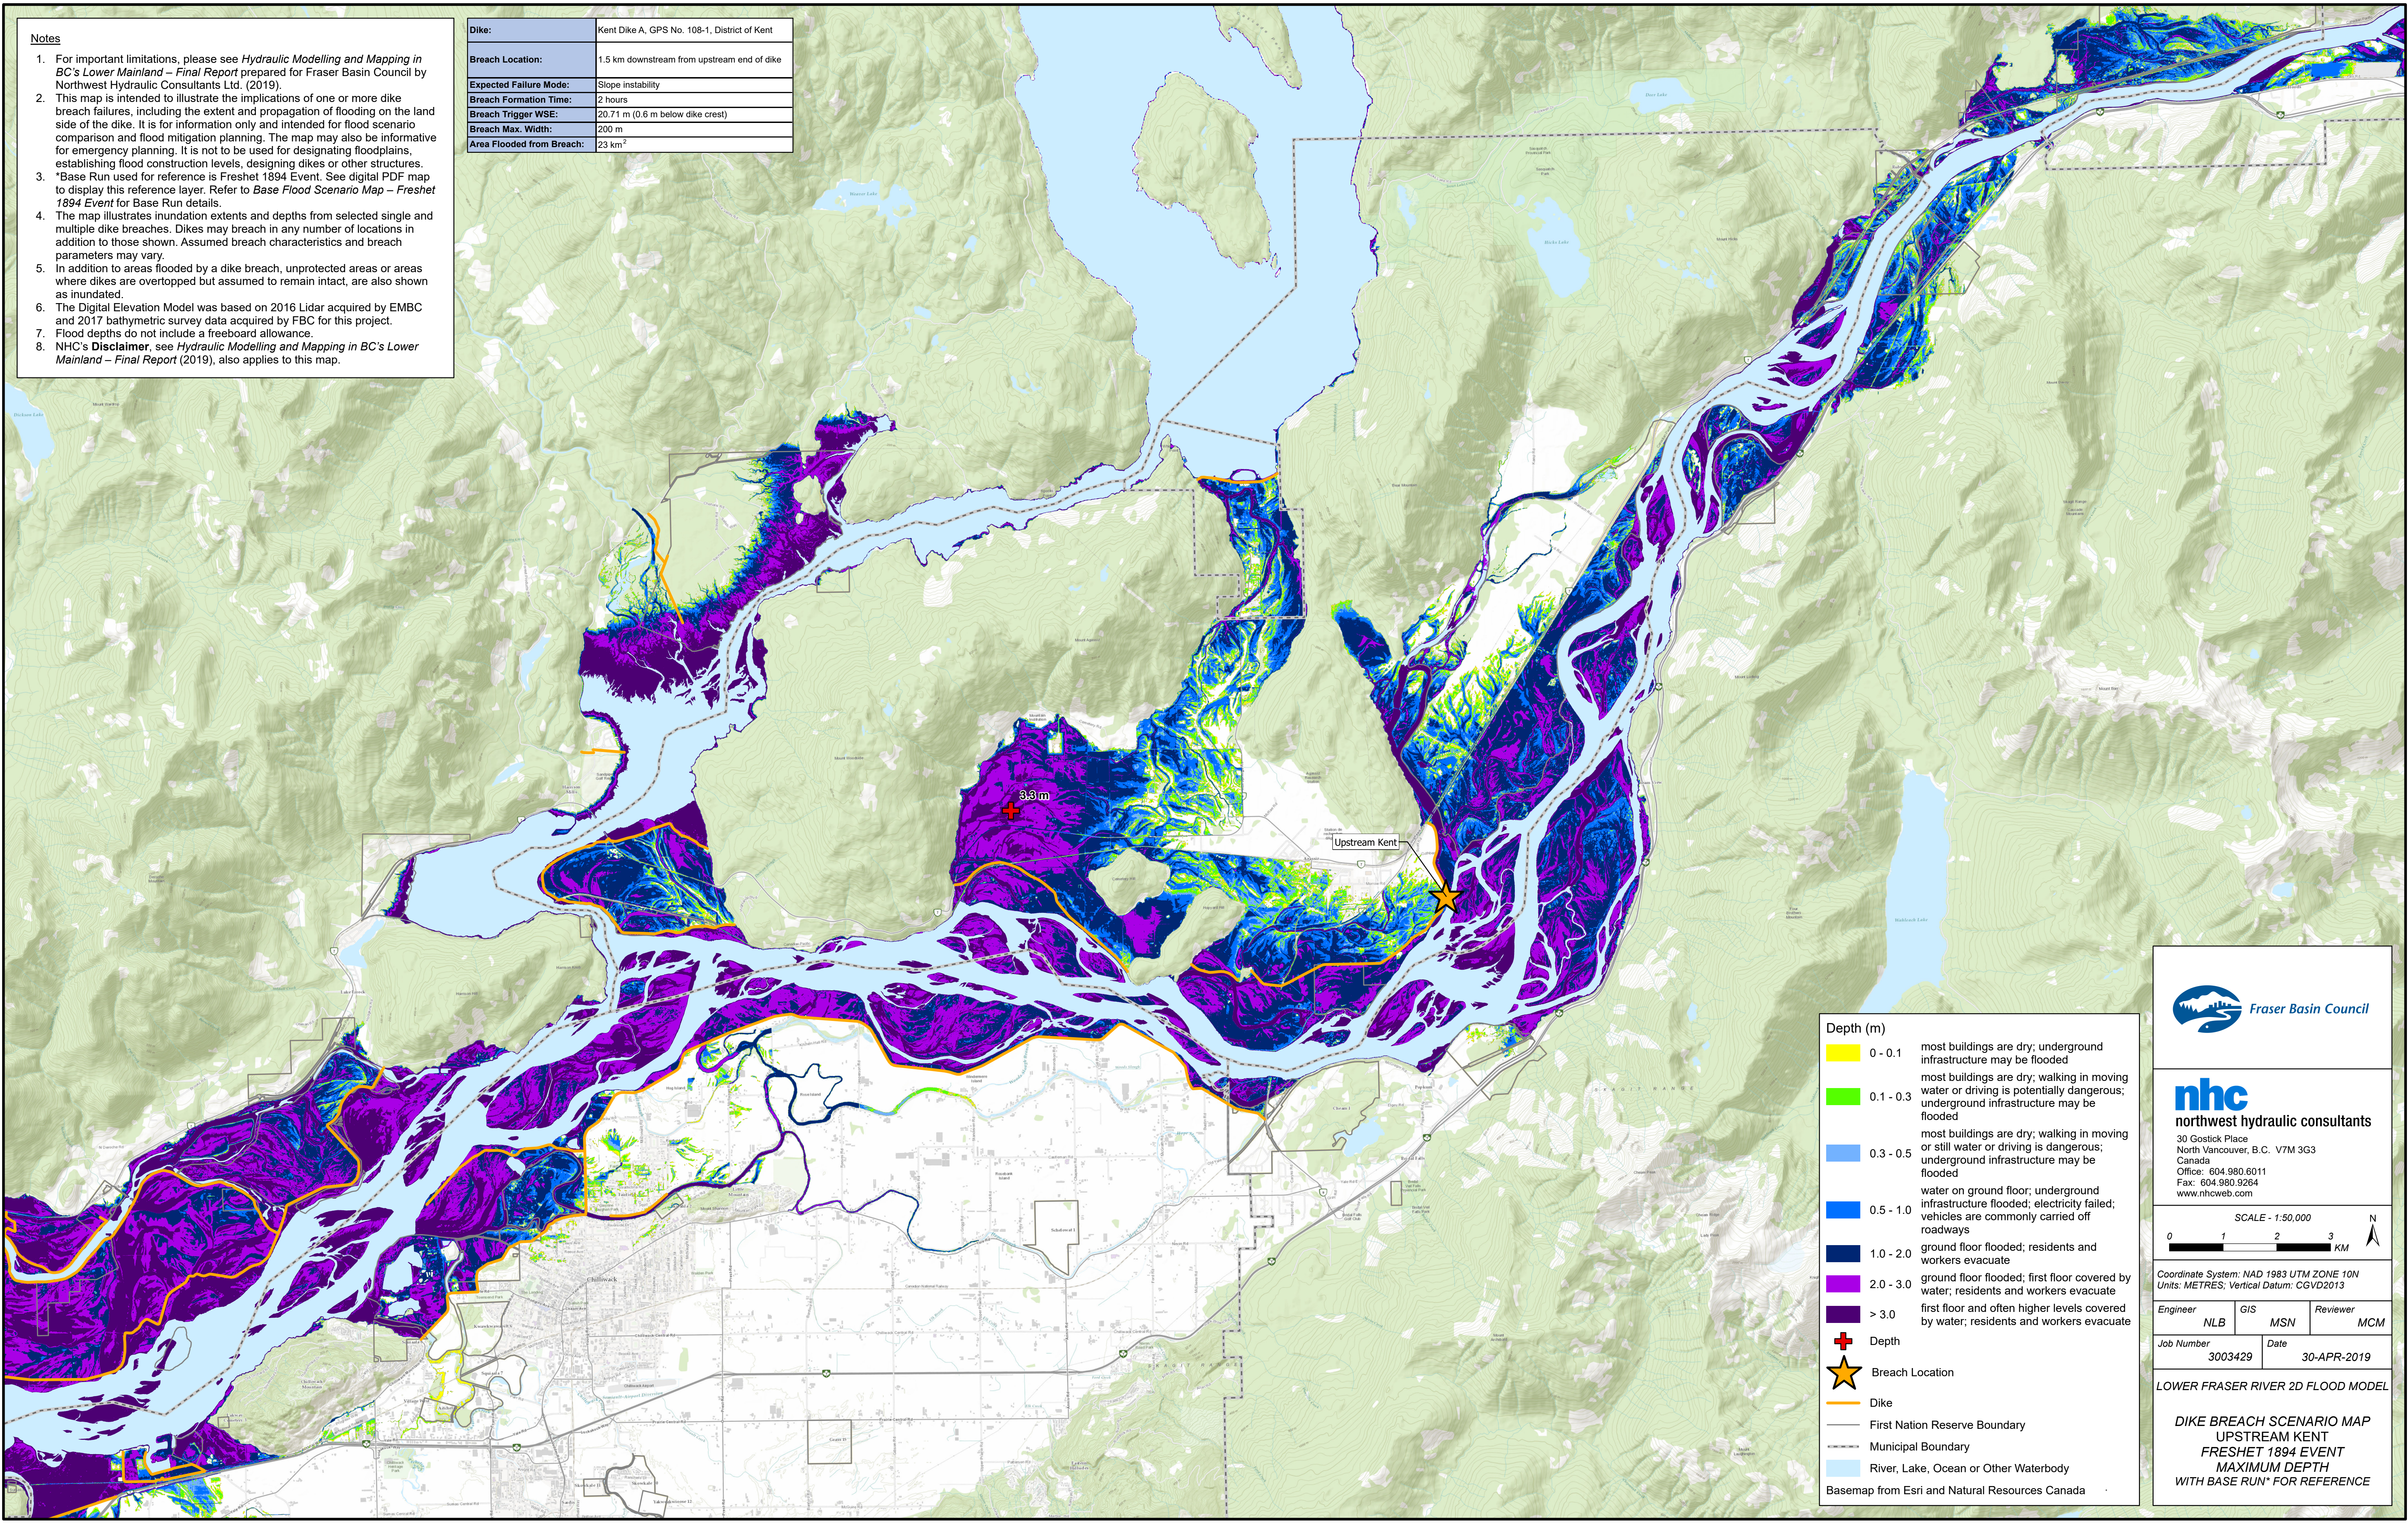
5. In addition to areas flooded by a dike breach, unprotected areas or areas where dikes are overtopped but assumed to remain intact, are also shown as inundated.

| Expected Failure Mode: | Slope instability |
| Breach Max. Width: | 200 m |
| Area Flooded from Breach: | 23 km <sup>2</sup> |

Depth (m)
