| Dike: | Vedder, GPS No. 2-2, City of Abbotsford |
| Breach Location: | 0.5 km upstream of Hwy 1 bridge crossing on the west side of the Vedder Canal |

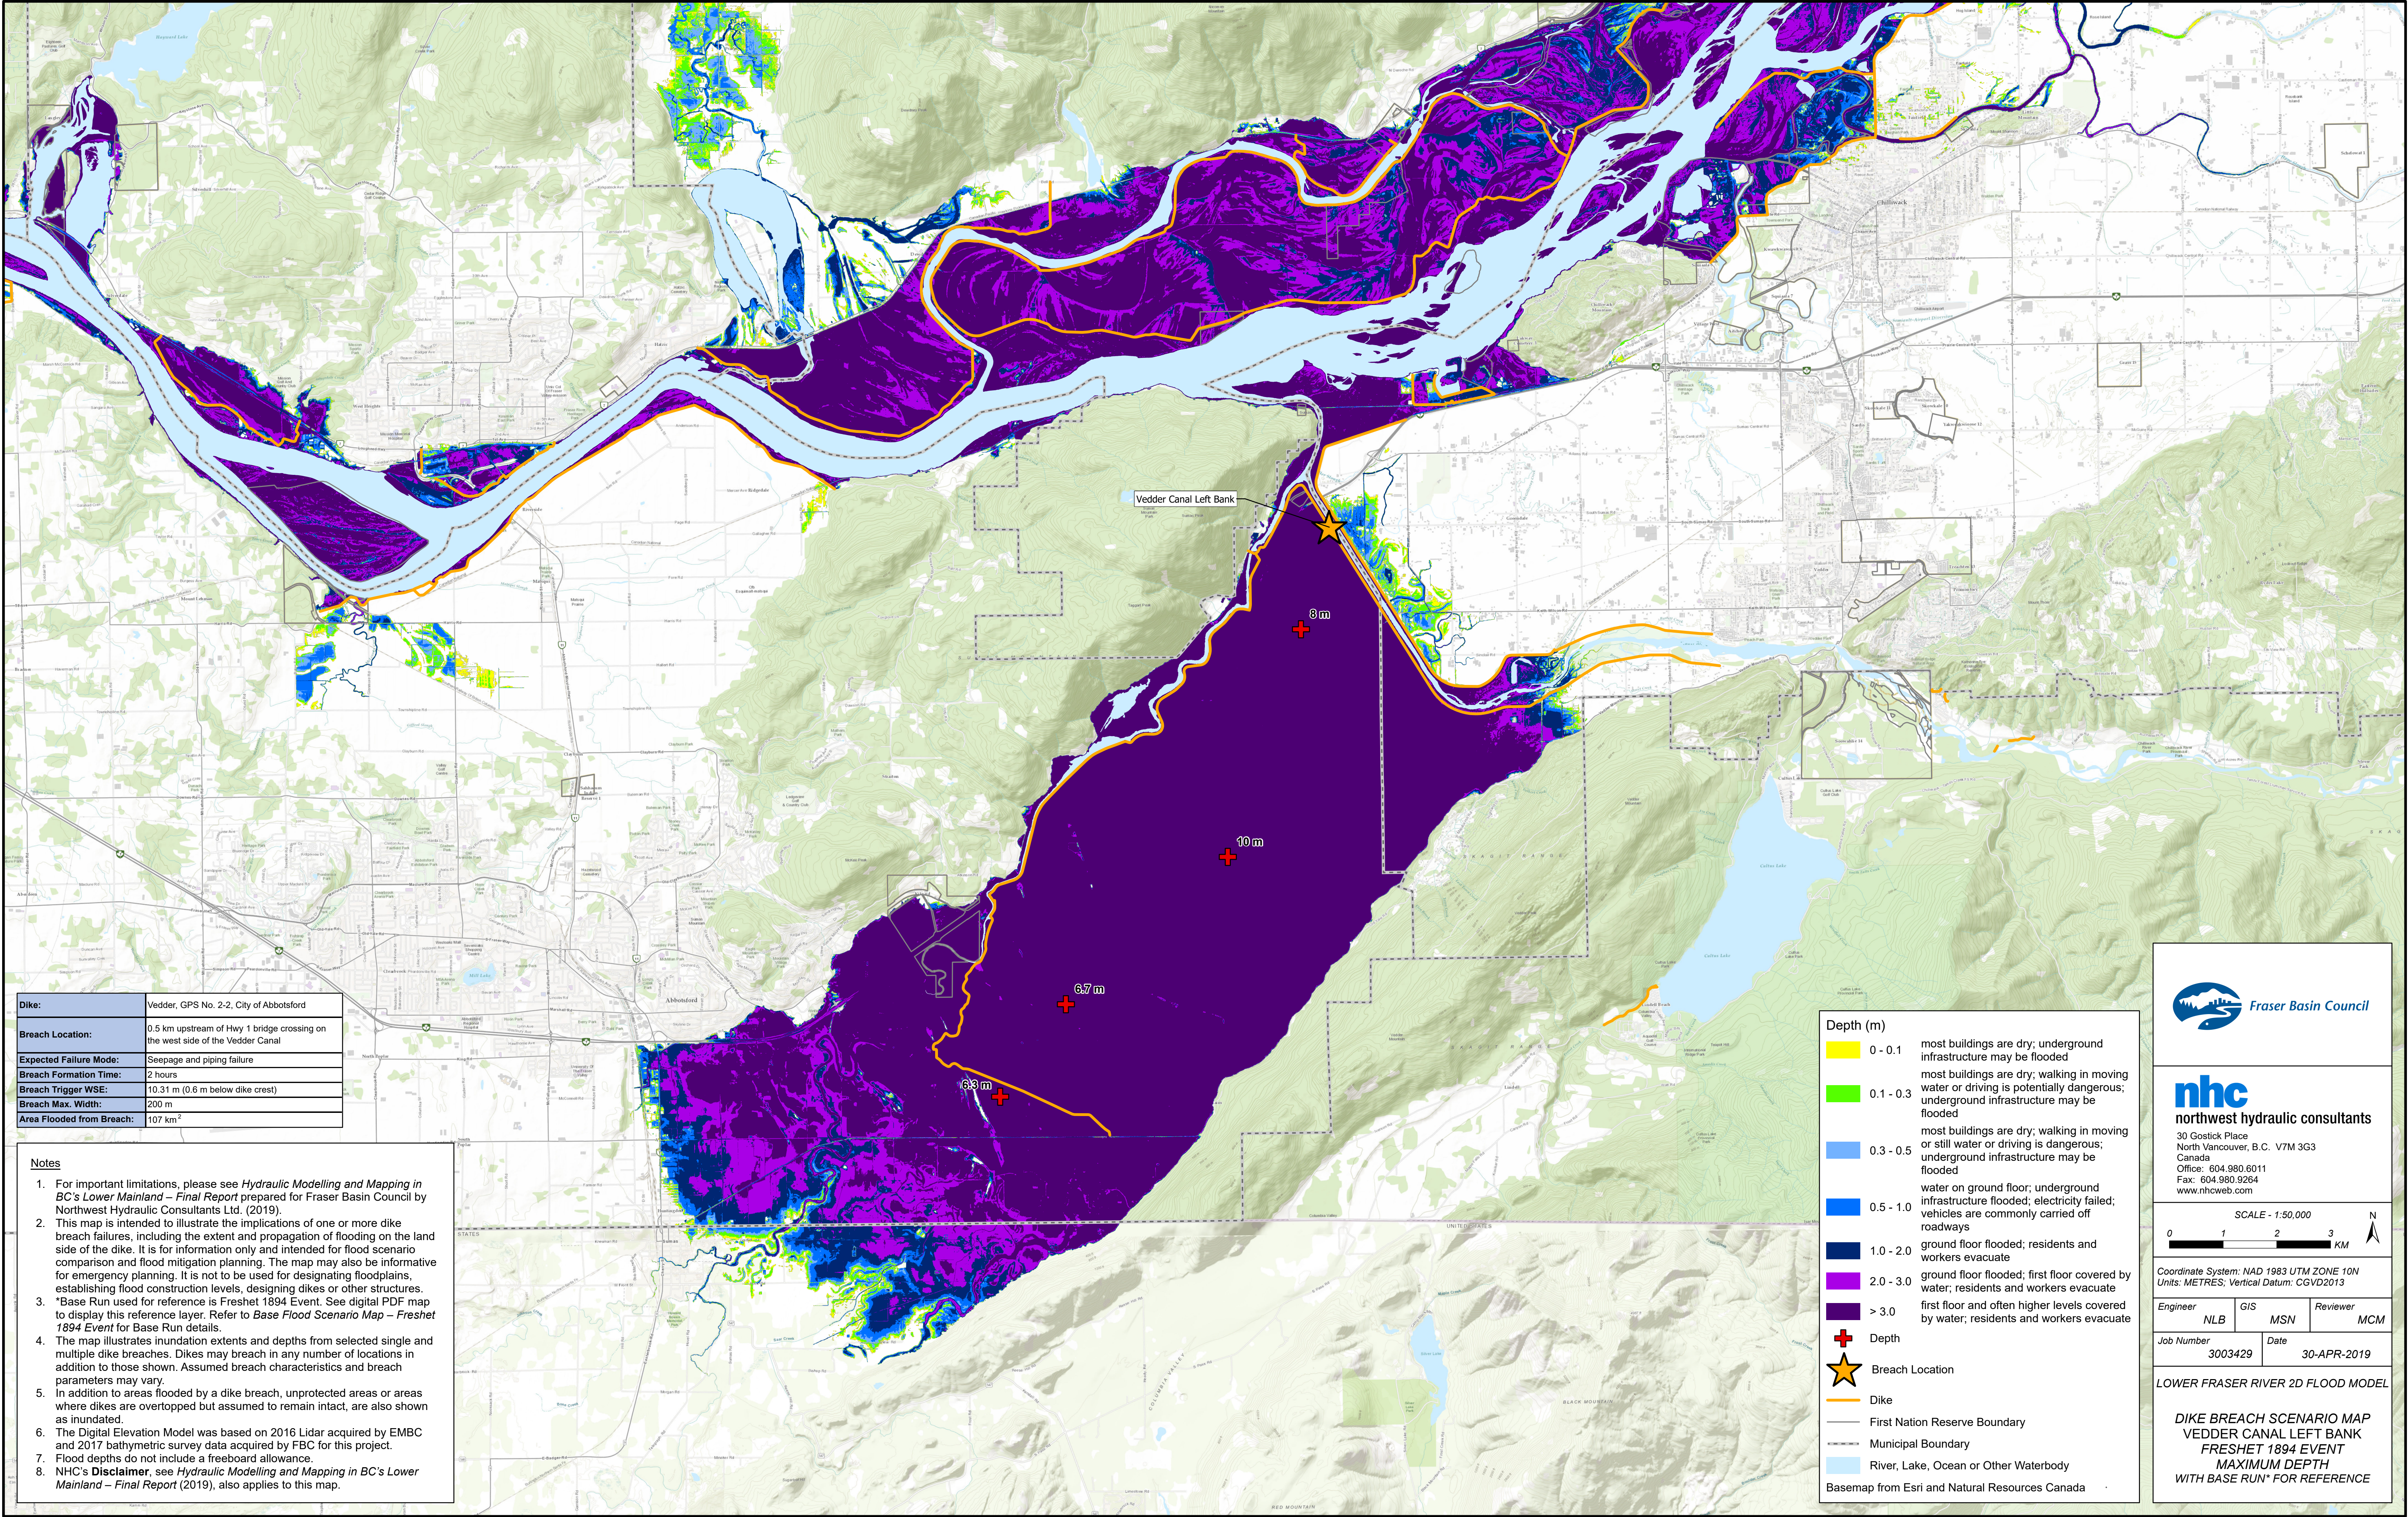
| Expected Failure Mode: | Seepage and piping failure |
| Breach Formation Time: | 2 hours |
| Breach Trigger WSE: | 10.31 m (0.6 m below dike crest) |
| Breach Max. Width: | 200 m |
| Area Flooded from Breach: | 107 km <sup>2</sup> |

- The map illustrates inundation extents and depths from selected single and multiple dike breaches. Dikes may breach in any number of locations in addition to those shown. Assumed breach characteristics and breach parameters may vary.

- In addition to areas flooded by a dike breach, unprotected areas or areas where dikes are overtopped but assumed to remain intact, are also shown as inundated.
