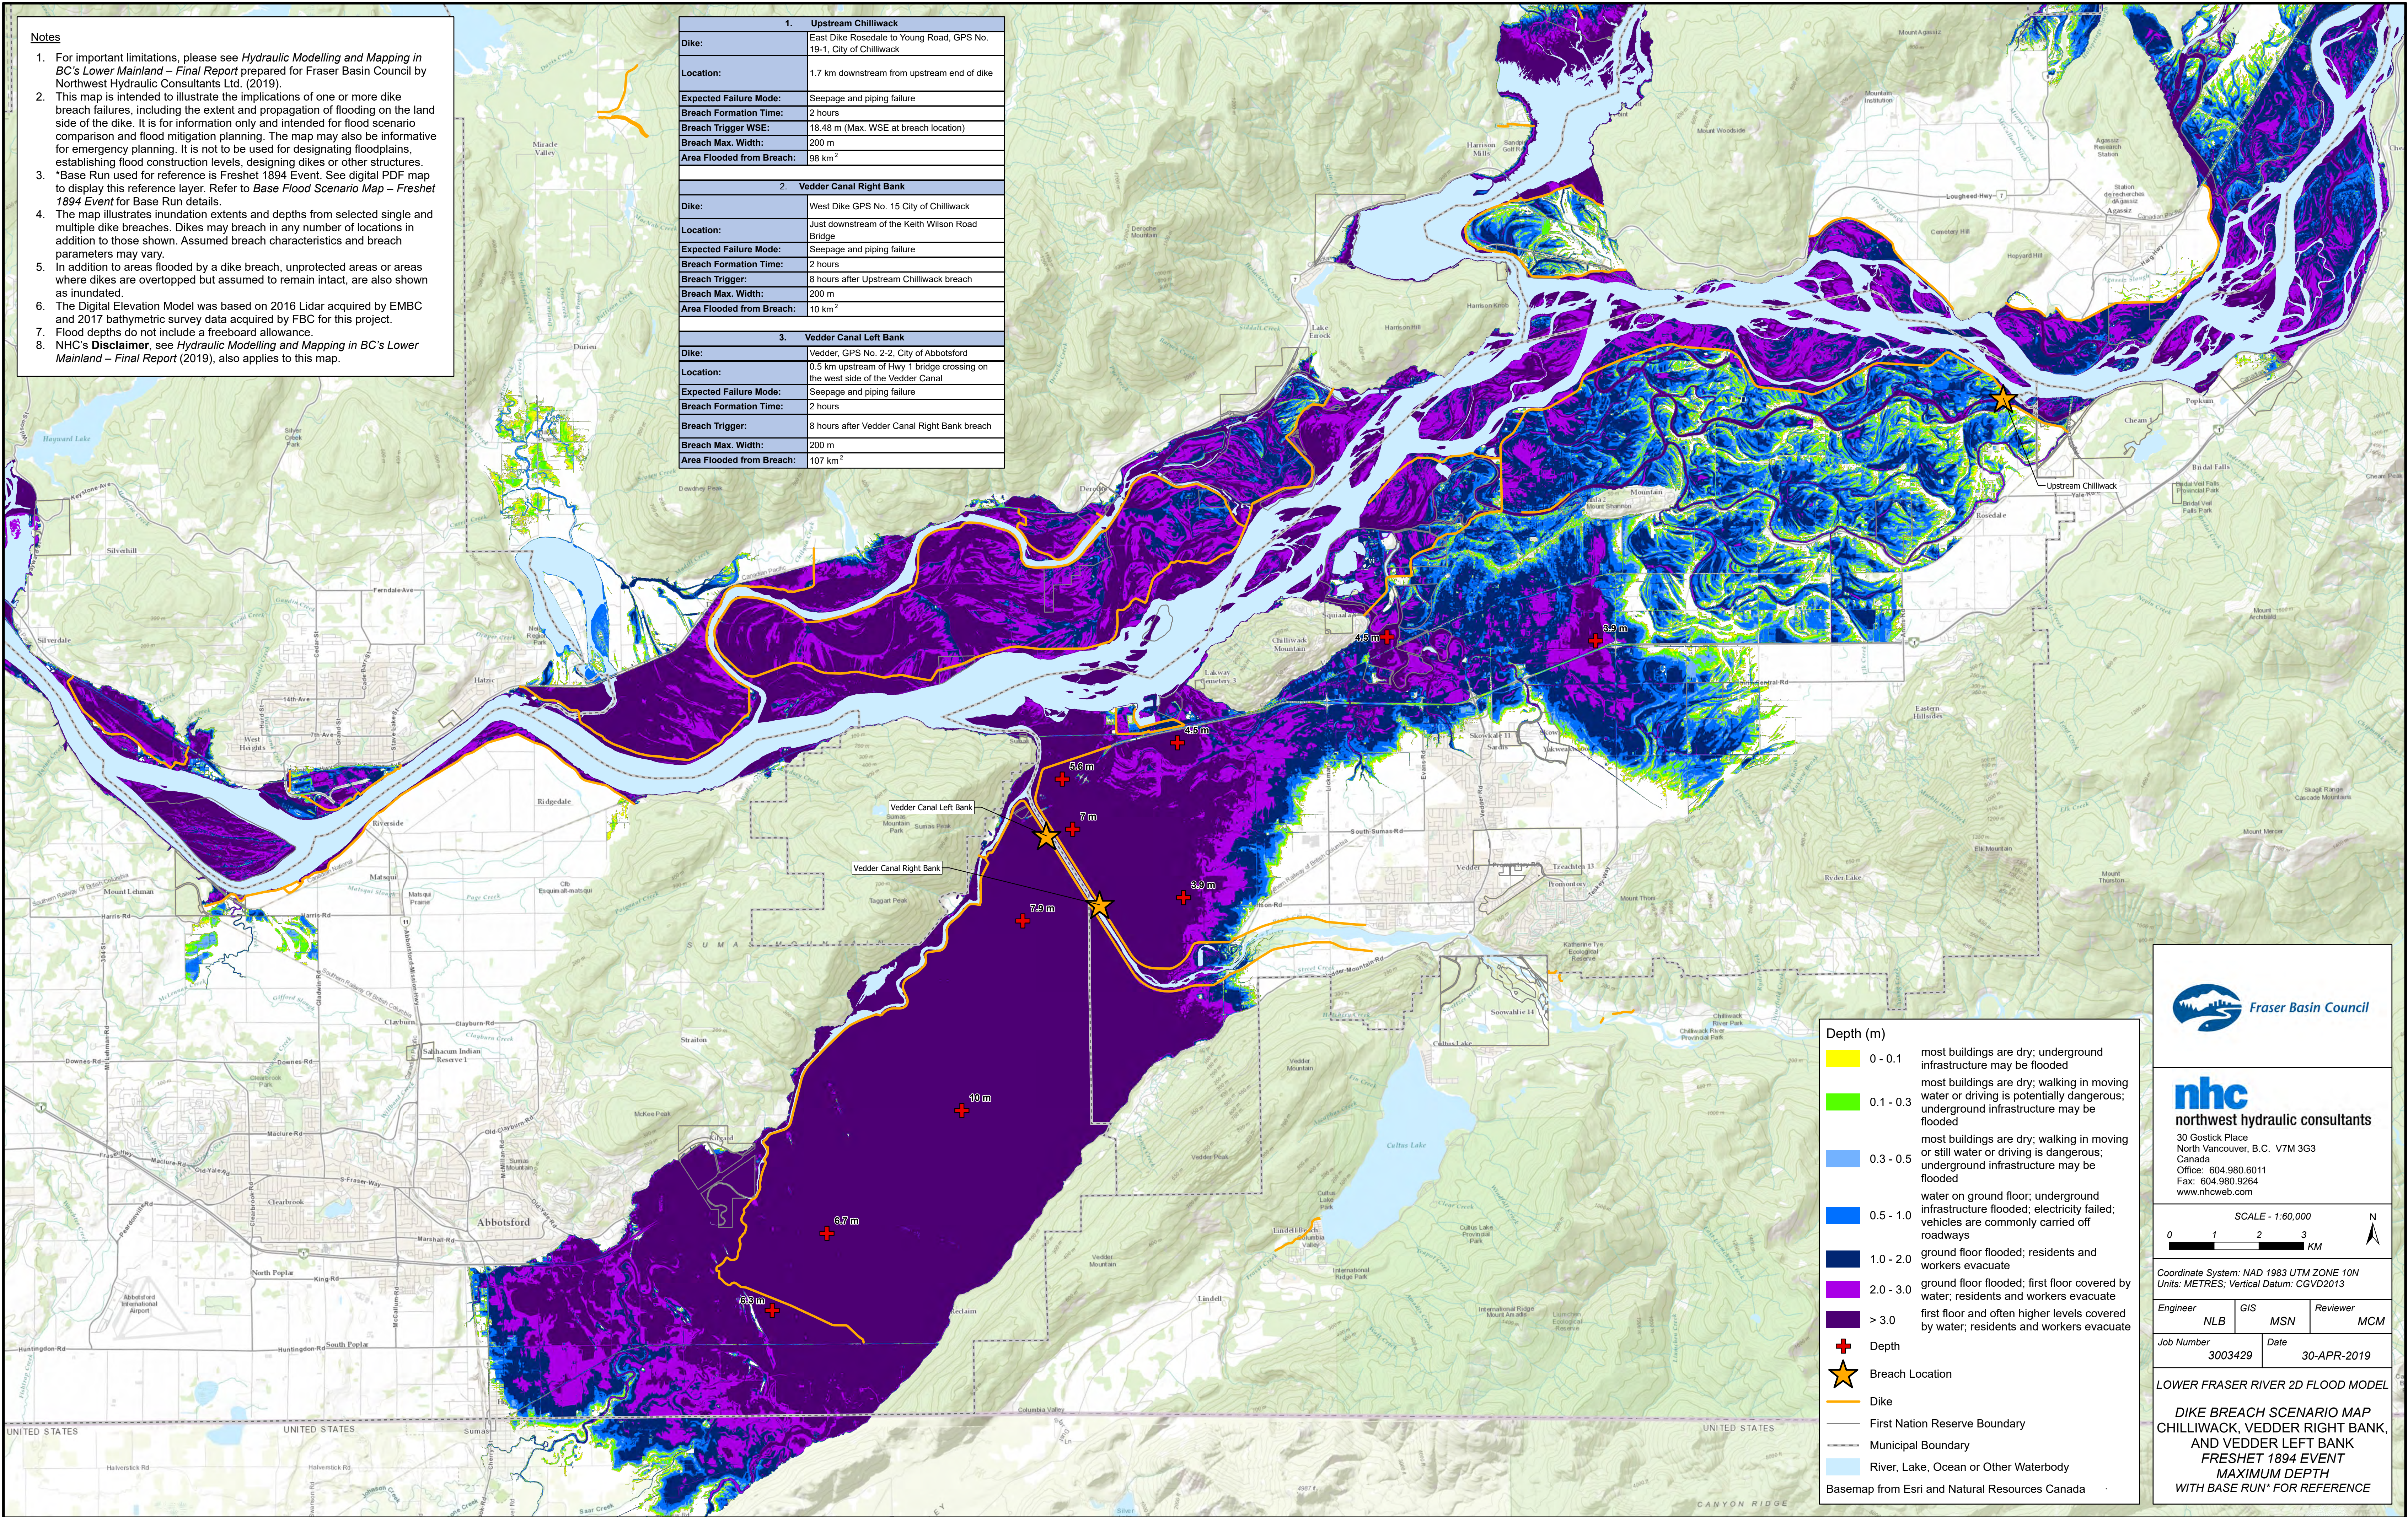
- The map illustrates inundation extents and depths from selected single and multiple dike breaches. Dikes may breach in any number of locations in addition to those shown. Assumed breach characteristics and breach parameters may vary.

1. Upstream Chilliwack	
Dike:	East Dike Rosedale to Young Road, GPS No. 19-1, City of Chilliwack
Location:	1.7 km downstream from upstream end of dike
Expected Failure Mode:	Seepage and piping failure
Breach Formation Time:	2 hours
Breach Trigger WSE:	18.48 m (Max. WSE at breach location)
Breach Max. Width:	200 m
Area Flooded from Breach:	98 km ²

2. Vedder Canal Right Bank	
Dike:	West Dike GPS No. 15 City of Chilliwack
Location:	Just downstream of the Keith Wilson Road Bridge
Expected Failure Mode:	Seepage and piping failure
Breach Formation Time:	2 hours
Breach Trigger:	8 hours after Upstream Chilliwack breach
Breach Max. Width:	200 m
Area Flooded from Breach:	10 km ²

3. Vedder Canal Left Bank	
Dike:	Vedder, GPS No. 2-2, City of Abbotsford
Location:	0.5 km upstream of Hwy 1 bridge crossing on the west side of the Vedder Canal
Expected Failure Mode:	Seepage and piping failure
Breach Formation Time:	2 hours
Breach Trigger:	8 hours after Vedder Canal Right Bank breach
Breach Max. Width:	200 m
Area Flooded from Breach:	107 km ²

- This map is intended to illustrate the implications of one or more dike breach failures, including the extent and propagation of flooding on the land side of the dike. It is for information only and intended for flood scenario comparison and flood mitigation planning. The map may also be informative for emergency planning. It is not to be used for designating floodplains, establishing flood construction levels, designing dikes or other structures.

- In addition to areas flooded by a dike breach, unprotected areas or areas where dikes are overtopped but assumed to remain intact, are also shown as inundated.

- The Digital Elevation Model was based on 2016 Lidar acquired by EMBC and 2017 bathymetric survey data acquired by FBC for this project.
- Flood depths do not include a freeboard allowance.
