Dike:	River Road Delta, GPS No. 45-1, City of Delta
Location:	175 m west of upstream end of dike at floodbox outlet of Cougar Canyon Creek (near Alex Fraser Bridge)
Expected Failure Mode:	Seepage and piping failure
Breach Formation Time:	2 hours
Breach Trigger WSE:	3.40 m (0.6 m below dike crest)
Breach Max. Width:	100 m
Area Flooded from Breach:	68 km ²

LOWER FRASER RIVER 2D FLOOD MODEL

DIKE BREACH SCENARIO MAP
UPSTREAM DELTA
FRESHET CLIMATE CHANGE
YEAR 2100, 0.2% AEP WITH 1 M SLR
MAXIMUM DEPTH
WITH BASE RUN* FOR REFERENCE

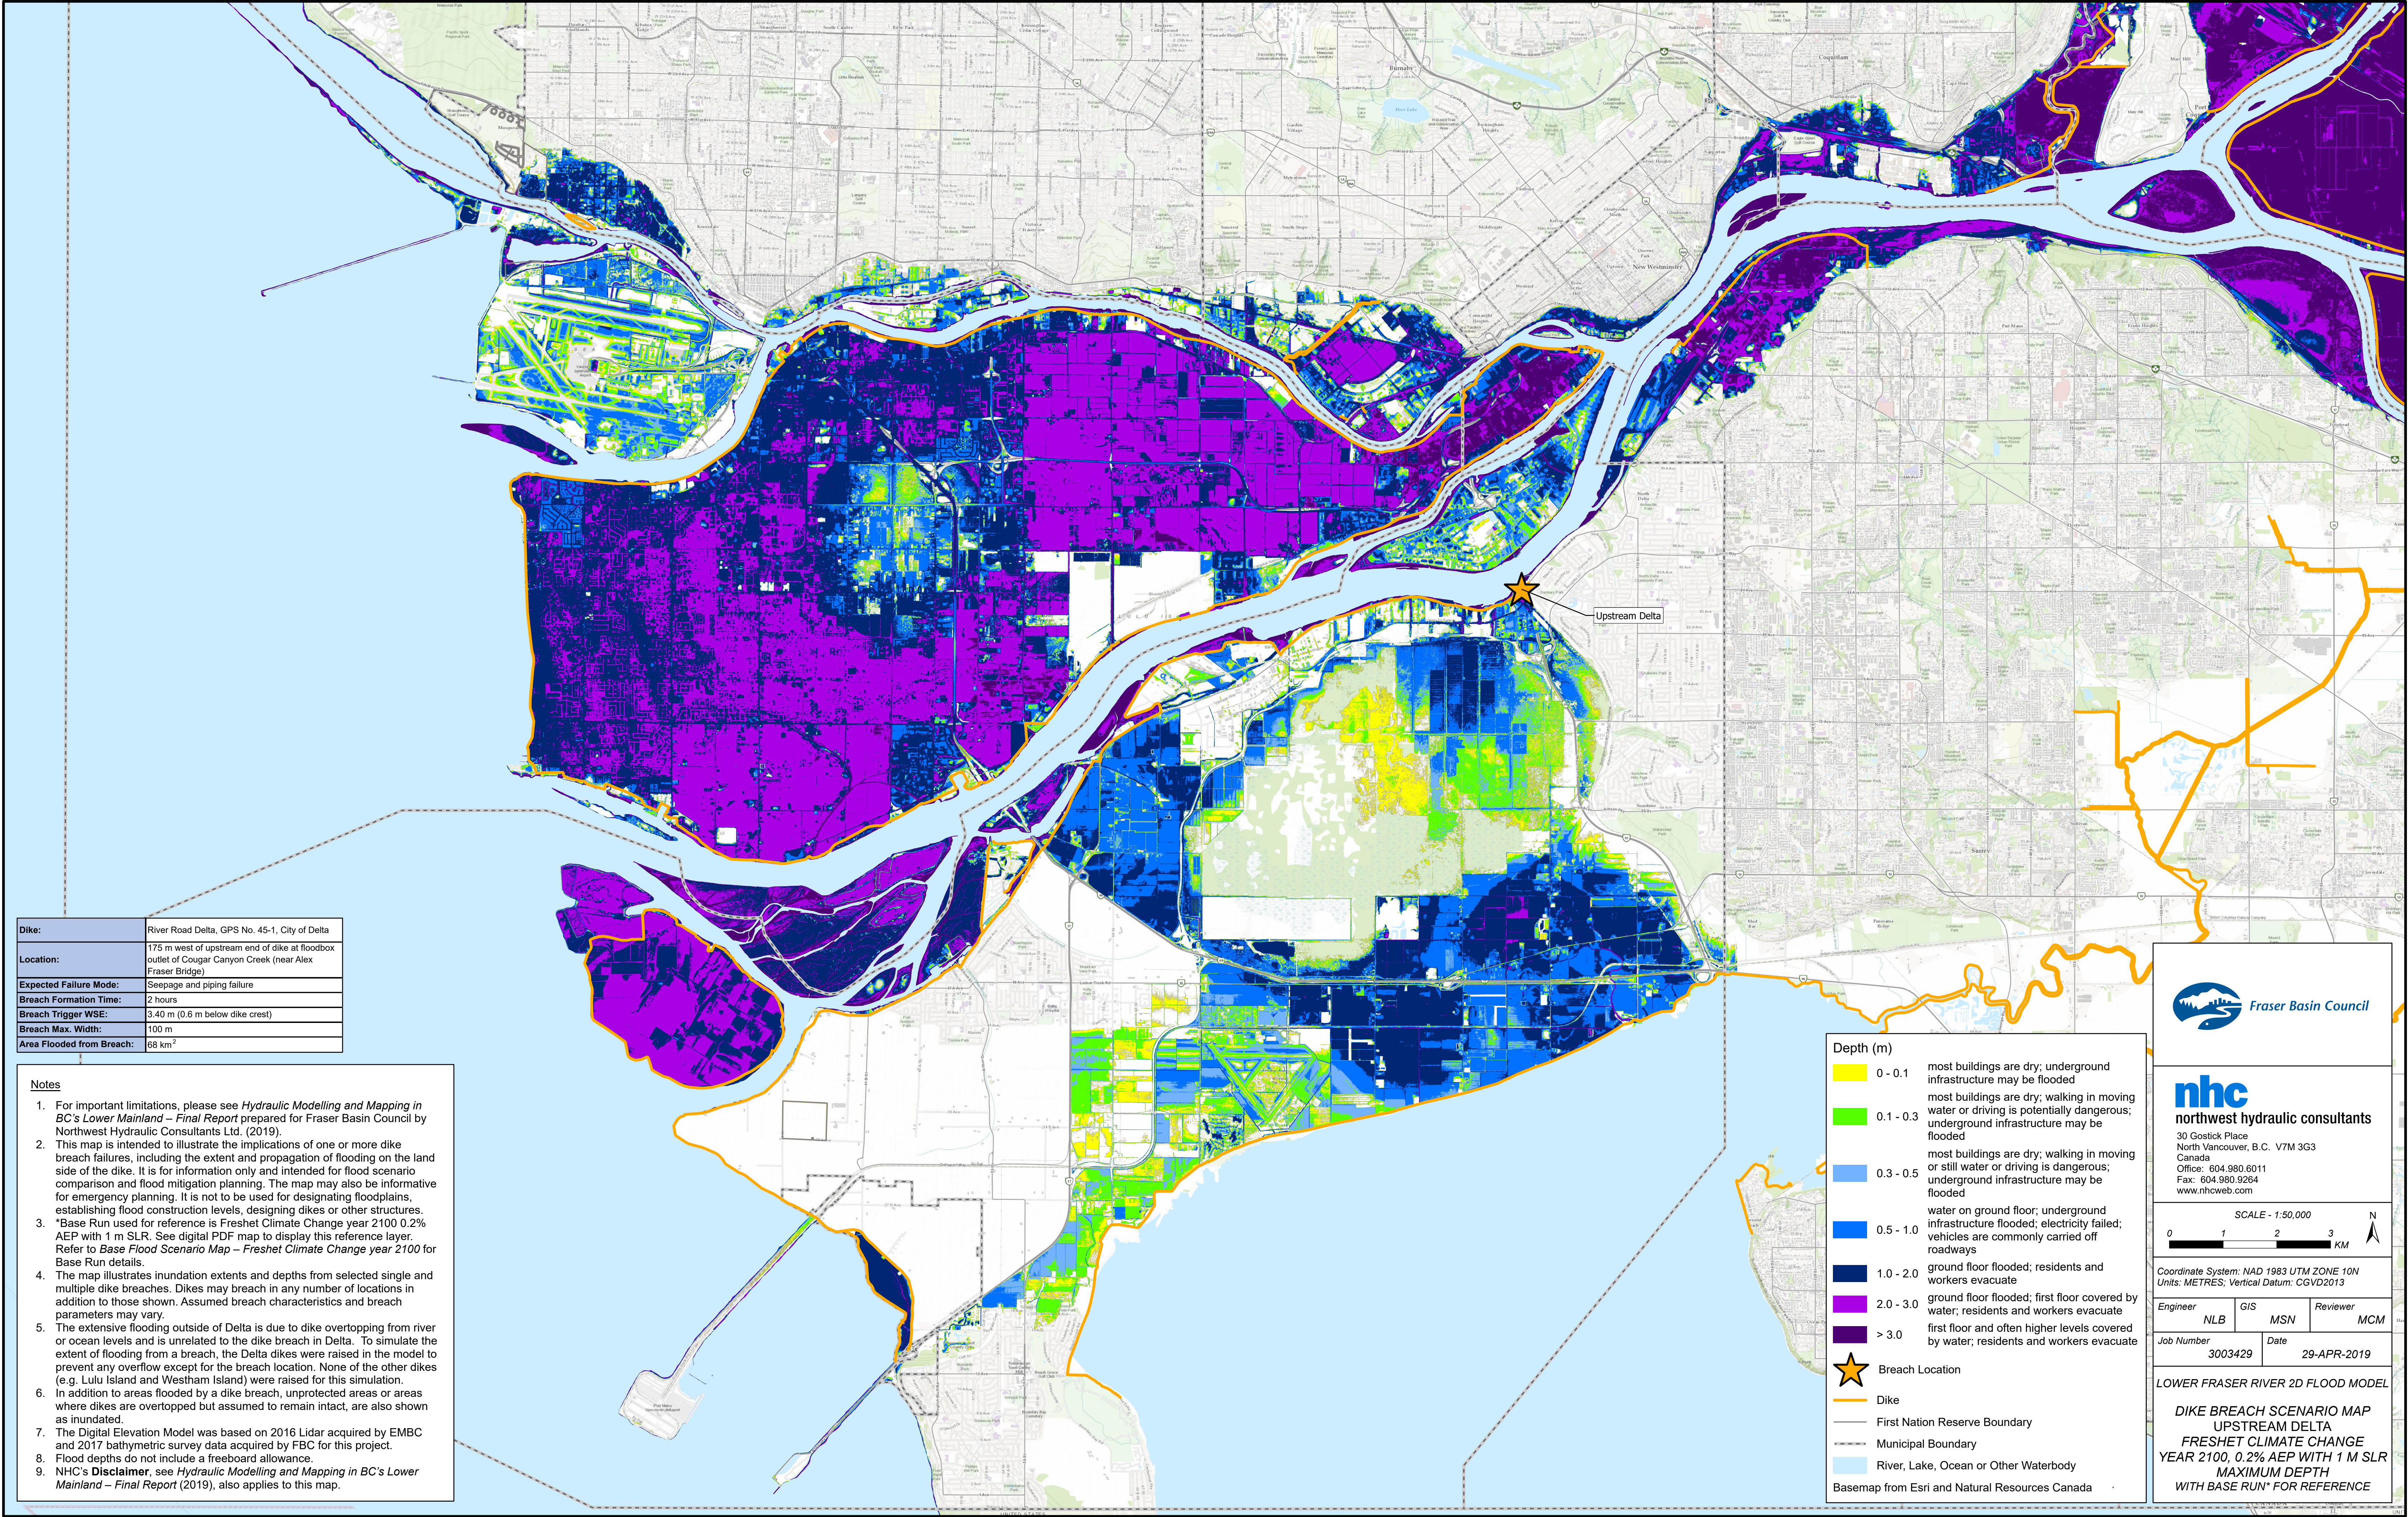
- The map illustrates inundation extents and depths from selected single and multiple dike breaches. Dikes may breach in any number of locations in addition to those shown. Assumed breach characteristics and breach parameters may vary.

- The extensive flooding outside of Delta is due to dike overtopping from river or ocean levels and is unrelated to the dike breach in Delta. To simulate the extent of flooding from a breach, the Delta dikes were raised in the model to prevent any overflow except for the breach location. None of the other dikes (e.g. Lulu Island and Westham Island) were raised for this simulation.

- In addition to areas flooded by a dike breach, unprotected areas or areas where dikes are overtopped but assumed to remain intact, are also shown as inundated.
